Analysis of Cotton Bale Tie Failures: A User's Guide

BY W. STANLEY ANTHONY,
Agricultural Engineer
U.S. Cotton Ginning Laboratory
ARS, USDA
Stoneville, Miss.

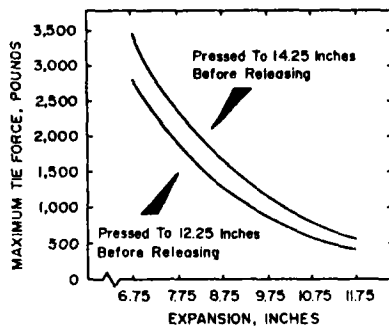
Figure 5. Effect of bale expansion on the maximum force on one tie of a compress universal density bale (with three percent moisture) 20 minutes after release of platen pressure.
